Abode Check Home Inspections

10009 Raod
Fairfax , VA 22031-

Marginal Summary

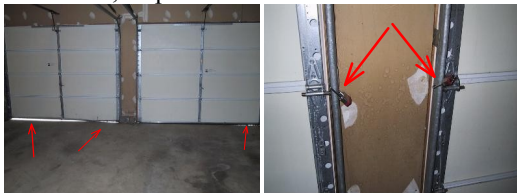
50. . **Garage Garage Doors:** Both doors locked :: Full evaluation not possible due to padlocks on each door. Recommend installing safety lines to all door springs for safety
Right door manual release is missing rope pull. Replace
Both doors; Improve bottom door seals

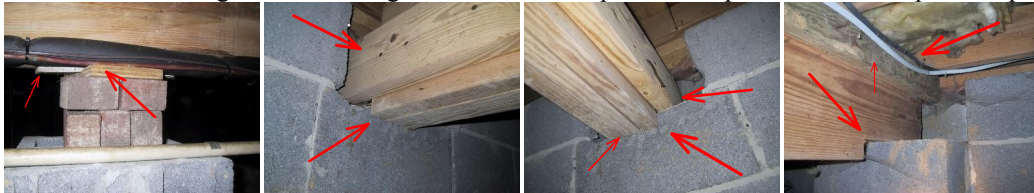
- Crawl Space Beams/ Joists/piers:** Laminated wood beam, dimensional lumber joists, concrete block piers: Left side of beam is not resting on concrete block wall. Shortage was filed repaired with 2 X 6 " extensions. Right side beam rests on concrete block wall but has been notched and joist does not extend enough to rest on beam. A 2 x 4 " has been scabbed in to support the joist. Beam is supported by block piers along the center sections but has been shimmed with frangible material. Recommend having a structural engineer evaluate and prescribe repairs. Then have qualified professionals perform repairs.
